Building Inspection Report

3973 Main St., Anytown, Fl.

Inspection Date:
6-20-2019

Report Number:
1352

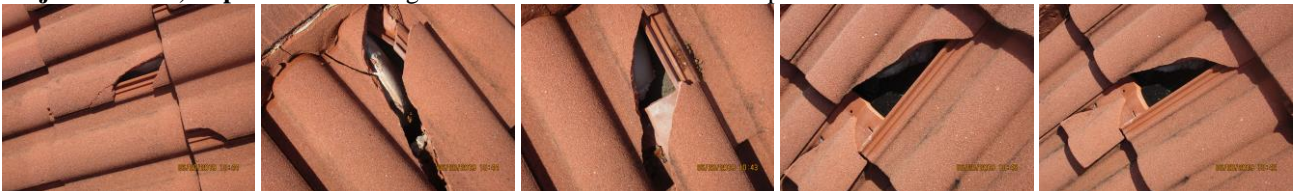
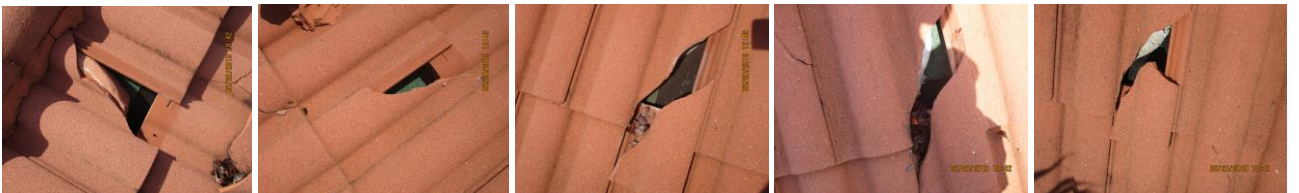
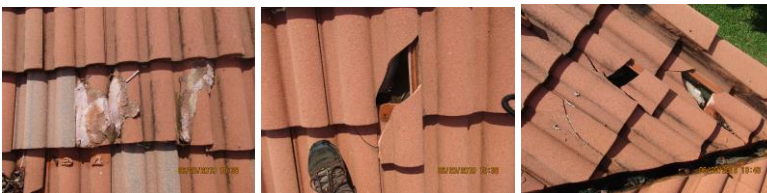
- **Major Concern, Repair:** The roofing is at end of life and should be replaced. Active leaks were observed.

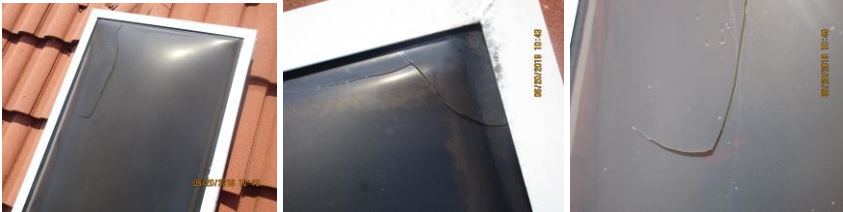
- **Repair:** The flashing leaks and should be replaced.

- **Repair:** The skylight is cracked. It should be repaired for safety and to avoid leaks.

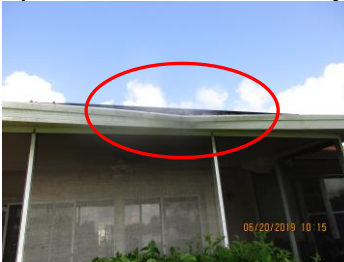
- **Repair:** Damaged gutters should be repaired or replaced as necessary to avoid spilling roof runoff around the building – a potential source of water entry or water damage.

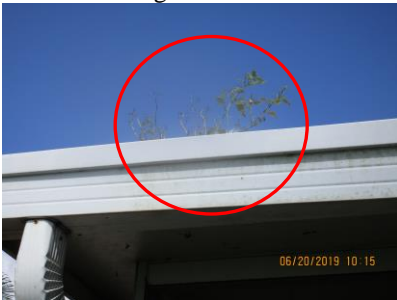
- **Repair:** The gutters require cleaning to avoid spilling roof runoff around the building – a potential source of water entry or water damage.

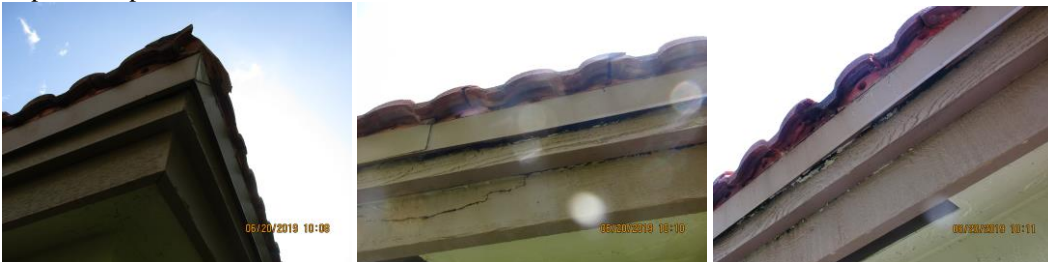
- **Repair:** The fascia (the wooden board to which the gutter is typically fastened) shows evidence of substantial rot. Repair or replacement is needed.

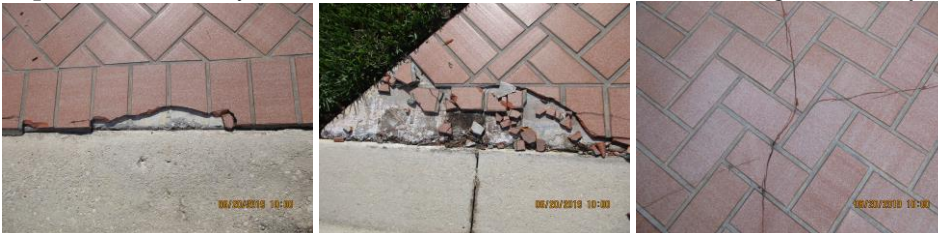
- **Repair:** The driveway surface is in a deteriorated condition. Resurfacing is necessary to correct this condition.

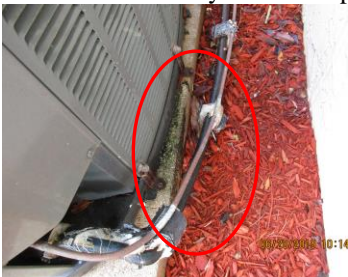
- **Deferred Cost Item:** As is not uncommon for homes of this age and location, the air conditioning system is old. It may require a slightly higher level of maintenance, and may be more prone to major component breakdown. Predicting the frequency or time frame for repairs on any mechanical device is virtually impossible.
- **Repair:** The temperature drop measured across the evaporator coil of the air conditioning system is lower than typical. This usually indicates that servicing is needed. A qualified heating and cooling technician should be consulted to further evaluate this condition and the remedies available.
- **Repair:** Damaged and or missing insulation on refrigerant lines should be repaired. These outside lines should be insulated all the way to the compressor unit to prevent loss of temperature in the lines.

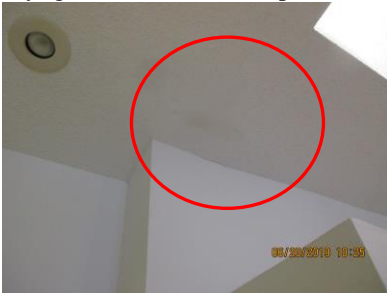
- **Monitor:** The interior finishes below the skylight show evidence of water damage. This condition suggests that the skylight has leaked in the past. This area should be carefully monitored.
