Wood-N-Water **Home Inspections**

Inspection Date: 8-20-2019

Report Number:

1371

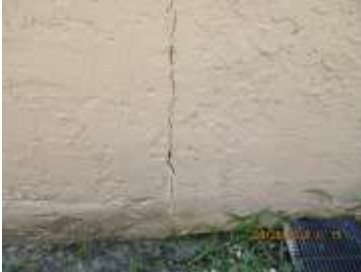
Exterior Walls

- **Monitor:** Common minor cracks were observed on the exterior walls of the house. This implies that structural movement has occurred. The location, size, shape of these cracks is common. The inspection did not find evidence of significant movement requiring immediate major repairs.

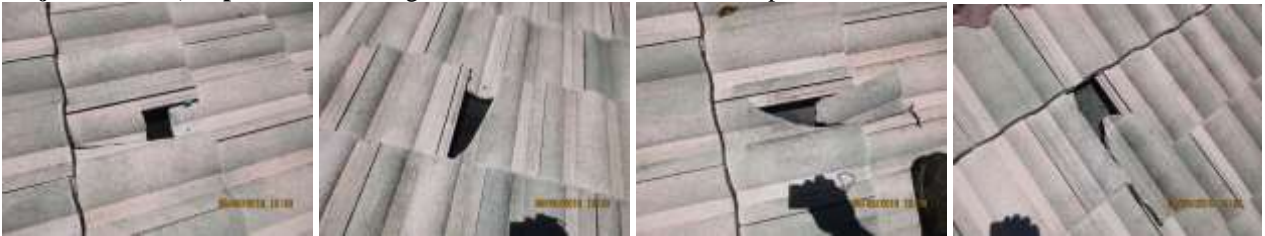
Sloped Roofing

The roof coverings are old and are at or near the end of its useful life.

- **Major Concern, Repair:** The roofing is at end of life and should be replaced.

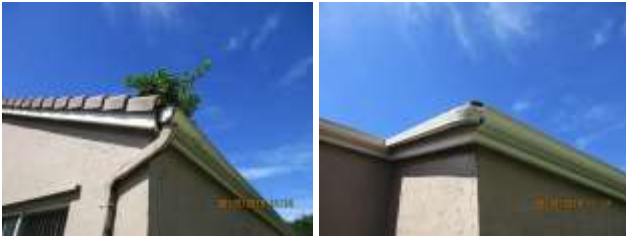
Gutters & Downspouts

- **Repair:** The gutters require cleaning to avoid spilling roof runoff around the building – a potential source of water entry or water damage.
- **Repair:** Damaged gutters should be repaired or replaced as necessary to avoid spilling roof runoff around the building – a potential source of water entry or water damage.

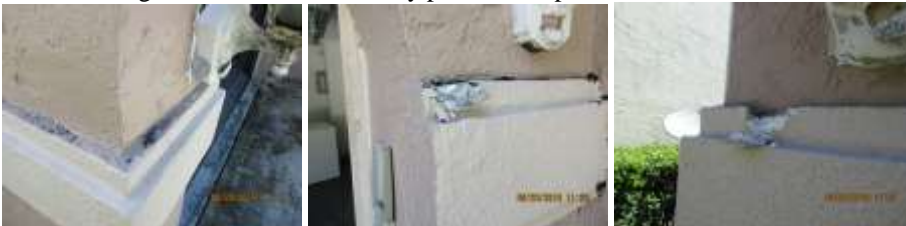
Exterior Walls

- **Repair:** Localized damage of the stucco exterior walls (staining and or cracks) should be repaired. There is extra risk of hidden damage in such areas caused by previous or present leaks that should be sealed.

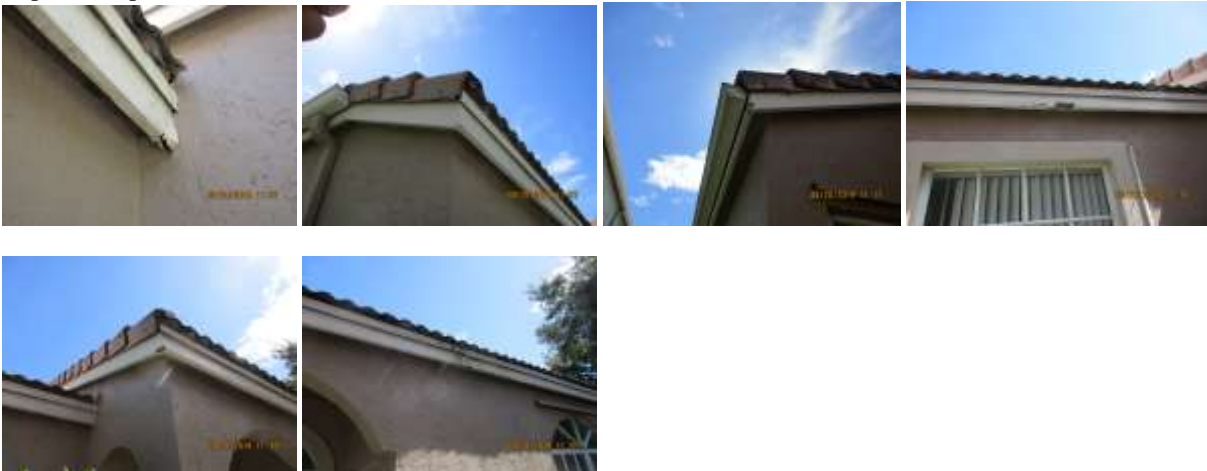
Exterior Eaves

- **Repair:** The fascia (the wooden board to which the gutter is typically fastened) shows evidence of substantial rot. Repair or replacement is needed.

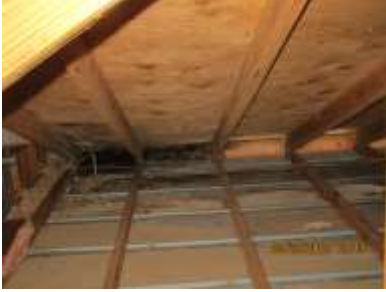
- **Repair:** Water staining/plywood delamination was observed on the eave. The roof is leaking in several areas.

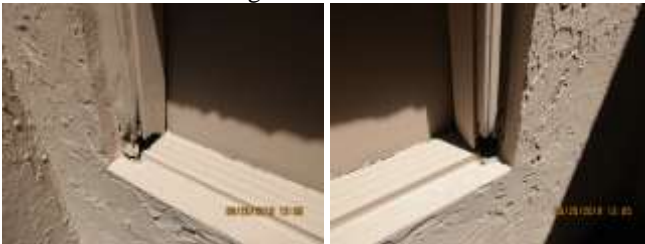
Exterior Walls

- **Repair:** Localized rot was observed in the siding. Following repair of the damaged areas (which should be combined with exterior painting/maintenance) proper maintenance of the siding and control of water from roof or surface runoff can avoid further damage.

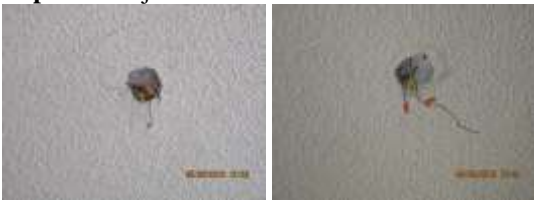
Distribution Wiring

- **Repair:** All junction boxes should be fitted with cover plates, in order to protect the wire connections.

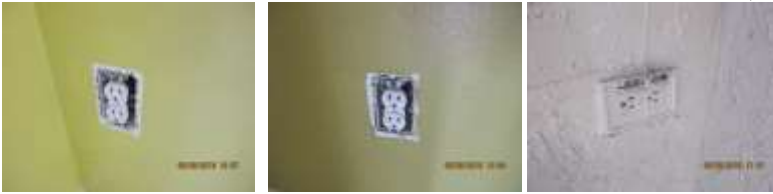
Outlets/Switches

- **Repair:** Missing outlet/switch cover plates should be replaced to avoid a shock hazard.

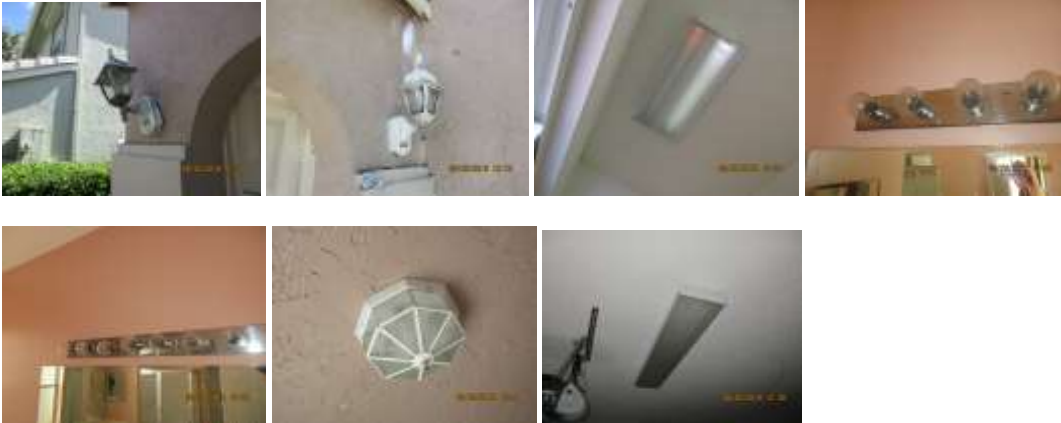
Lights

- **Repair:** Several lights are inoperative/damaged. If the bulbs are not blown, the circuit should be repaired.

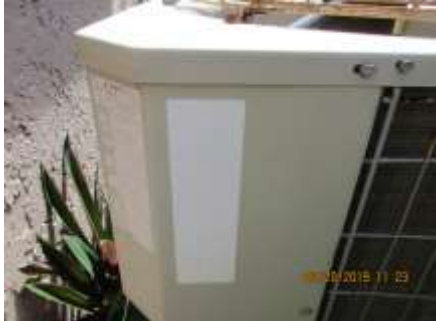
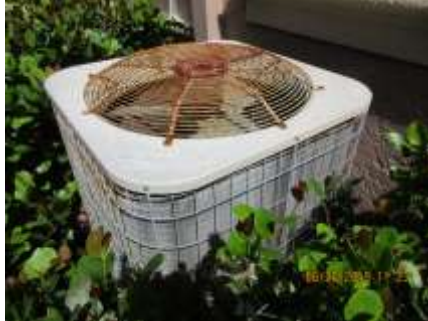
The data plate was not legible; The exact age could not be determined. The condenser appears to be greater than 10 years.

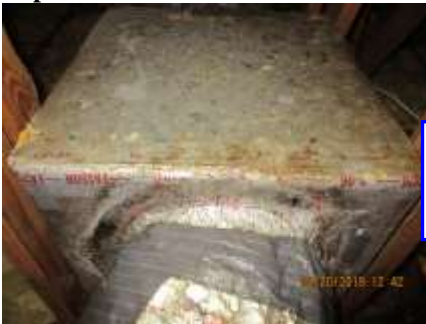
Attic / Roof

- **Repair:** There is evidence of vermin activity. A pest control specialist should be consulted in this regard.

Rodent feces and urine are widespread in the attic spaces.

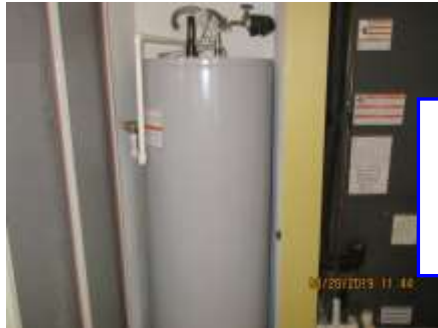
The data plate was not visible. The water heater age could not be determined.

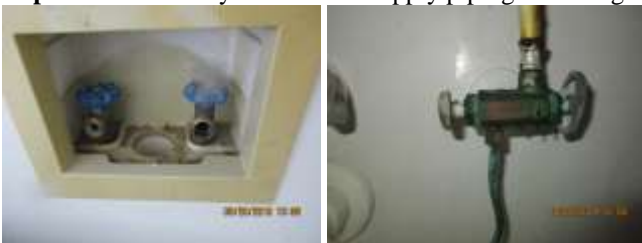
Supply Plumbing

- **Repair:** The laundry and kitchen supply piping is leaking.

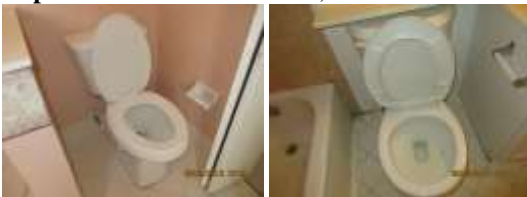
- **Repair:** The toilets are loose; recommend securing to the floor as needed.

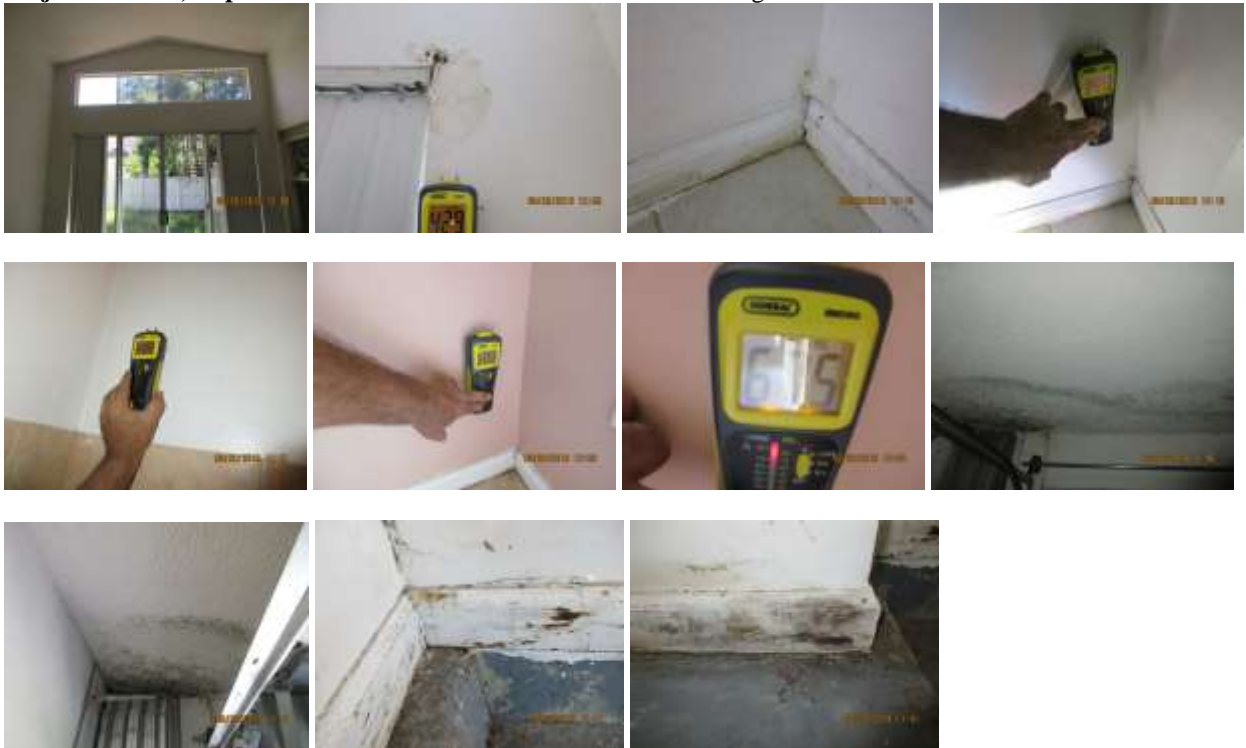
Wall / Ceiling Finishes

- **Major Concern, Repair:** Water infiltration and substantial bacterial growth was observed in several areas.

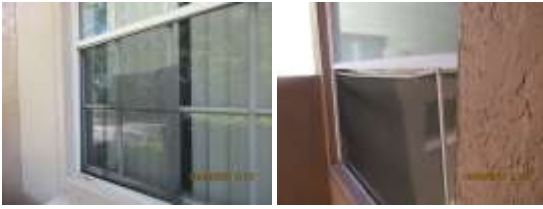
Windows

- **Repair:** Damaged screens were noted on windows.
