Building Inspection Report

3973 Main St., Anytown, Fl.

Inspection Date:
6-20-2019

Report Number:
1352

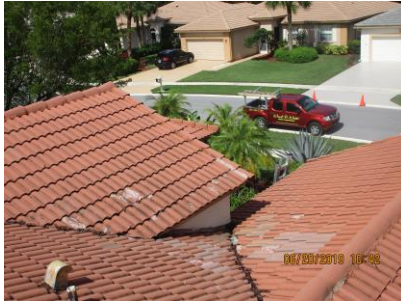
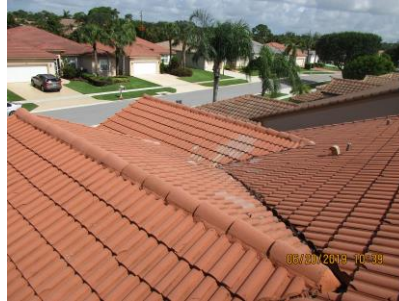
- **Major Concern, Repair:** The roofing is at end of life and should be replaced. Active leaks were observed.

- **Repair:** The flashing leaks and should be replaced.
- **Repair:** The skylight is cracked. It should be repaired for safety and to avoid leaks.

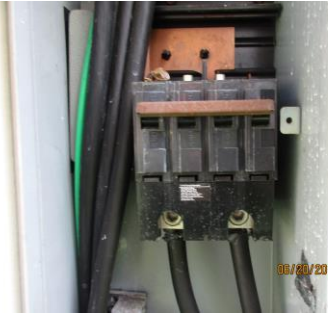
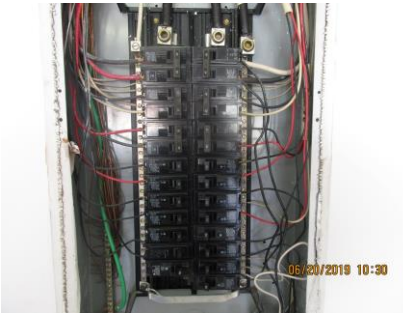
- **Repair, Safety Issue:** The service entrance conduit is decayed, exposing the service entrance wires. This condition should be promptly repaired for safety.

- **Repair:** An outlet is inoperative. This outlet and circuit should be investigated.

- **Repair:** The damaged light fixture should be repaired or replaced.

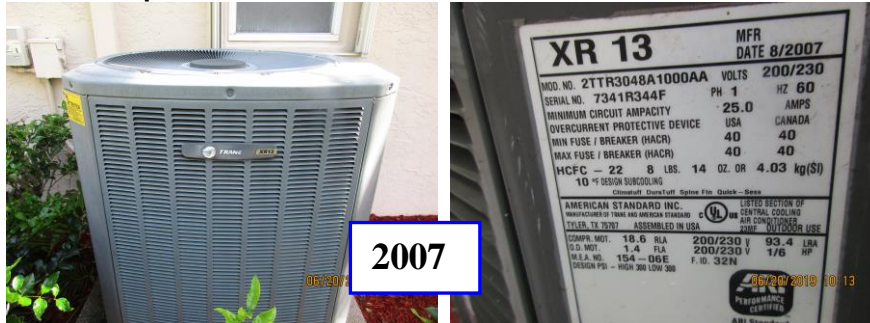
- **Repair:** The temperature drop measured across the evaporator coil of the air conditioning system is lower than typical. This usually indicates that servicing is needed. A qualified heating and cooling technician should be consulted to further evaluate this condition and the remedies available.
- **Repair:** Damaged and or missing insulation on refrigerant lines should be repaired. These outside lines should be insulated all the way to the compressor unit to prevent loss of temperature in the lines.

- **Deferred Cost Item:** As is not uncommon for homes of this age and location, the air conditioning system is old. It may require a slightly higher level of maintenance, and may be more prone to major component breakdown. Predicting the frequency or time frame for repairs on any mechanical device is virtually impossible.
